**CONNECTICUT RIVER BASIN  
MIDDLEFIELD, CONNECTICUT**

**BESECK LAKE DAM**

**CT 00381**

**PHASE I INSPECTION REPORT  
NATIONAL DAM INSPECTION PROGRAM**

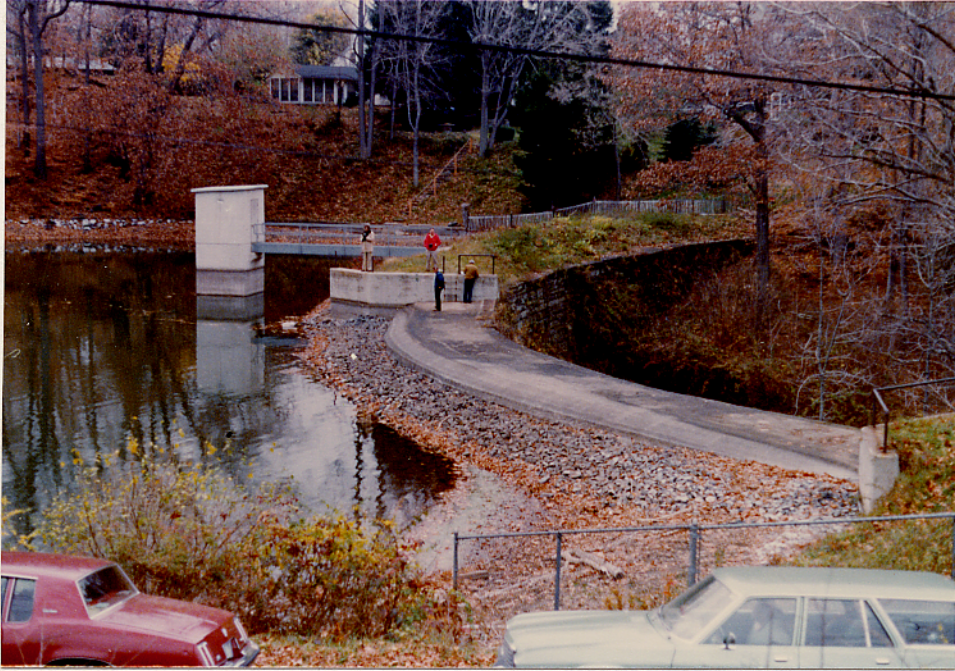
Overview from right abutment

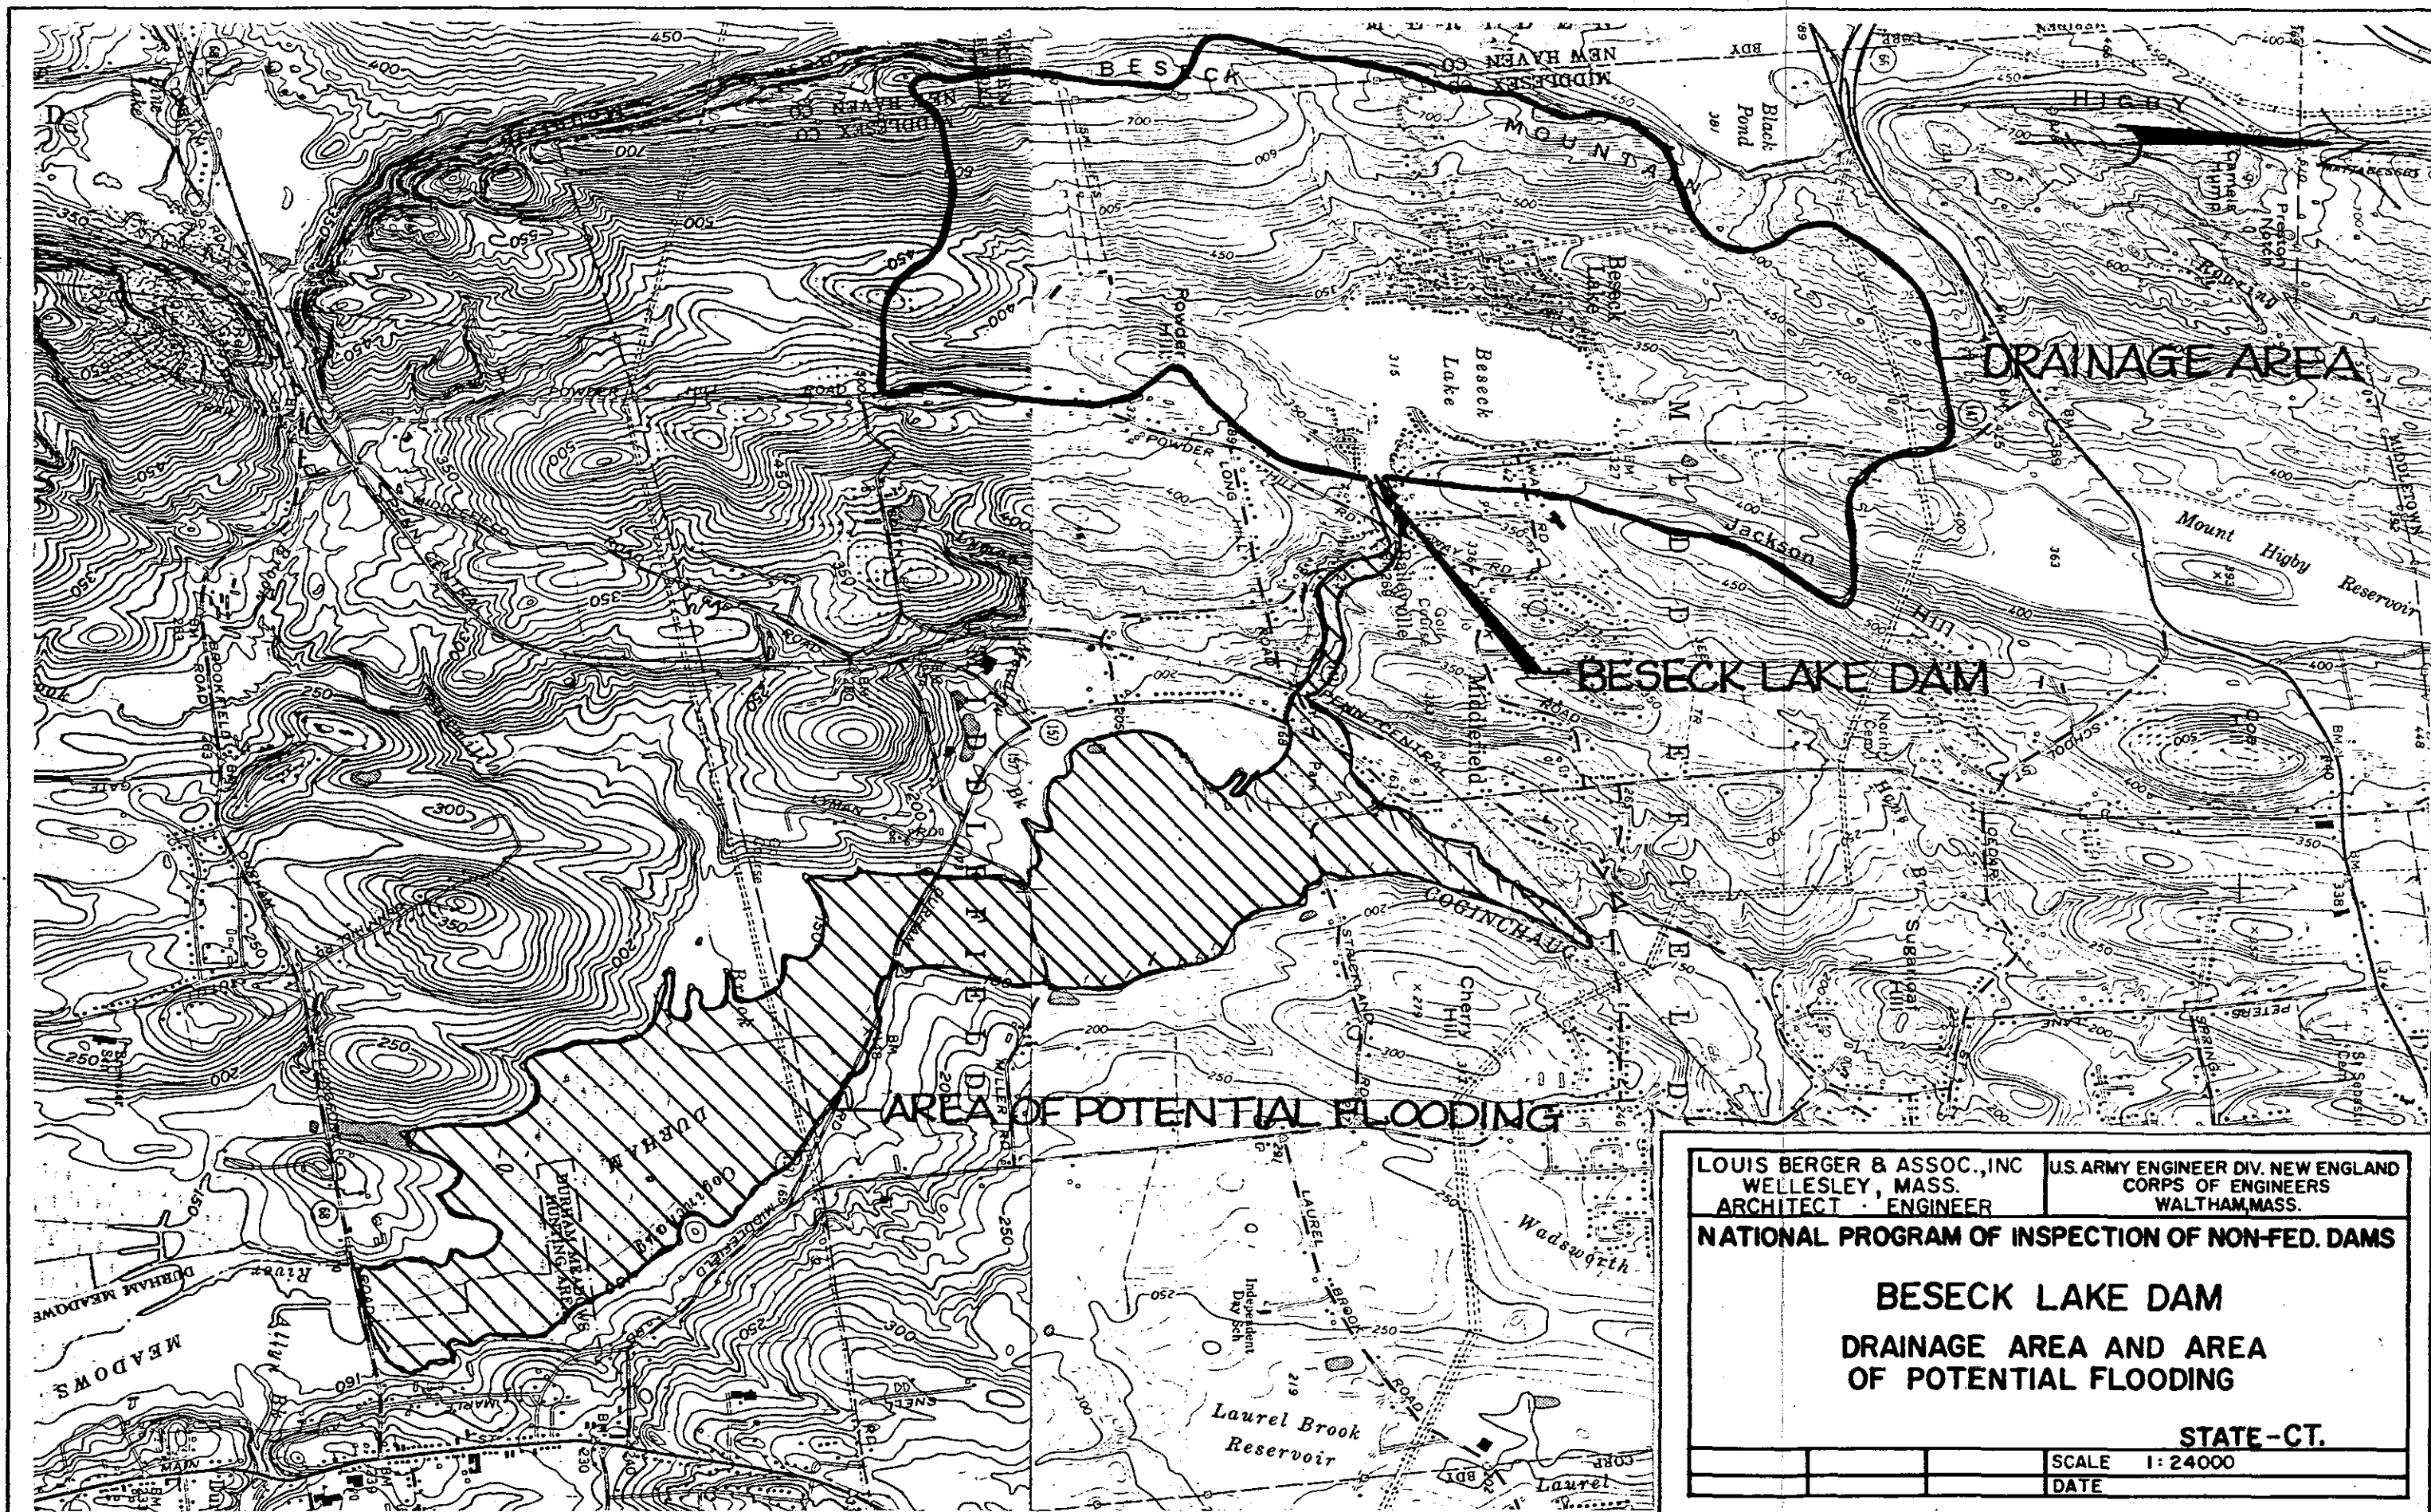
Figure 5, D-12

river for this depth would be about 3,000 cfs. Except for several highway crossings and a small millpond, there do not appear to be any major installations on the Coginchaug River between Wadsworth Falls and the Connecticut River which would be damaged by this magnitude of flow. Delineated on Figure 5, Sheet D-12 (quad sheet graphic) is the approximate area which could be flooded by a breach failure of the dam.
